**A MEETING OF THE TOWN OF TELLURIDE HISTORIC AND  
ARCHITECTURAL REVIEW COMMISSION (HARC) CHAIRPERSON**

**1. PROJECT TITLE:** Gerber Residence

**2. PROJECT TITLE:** Gluckstern Shed Alteration

## GERBER ADDITIONS & ALTERATIONS

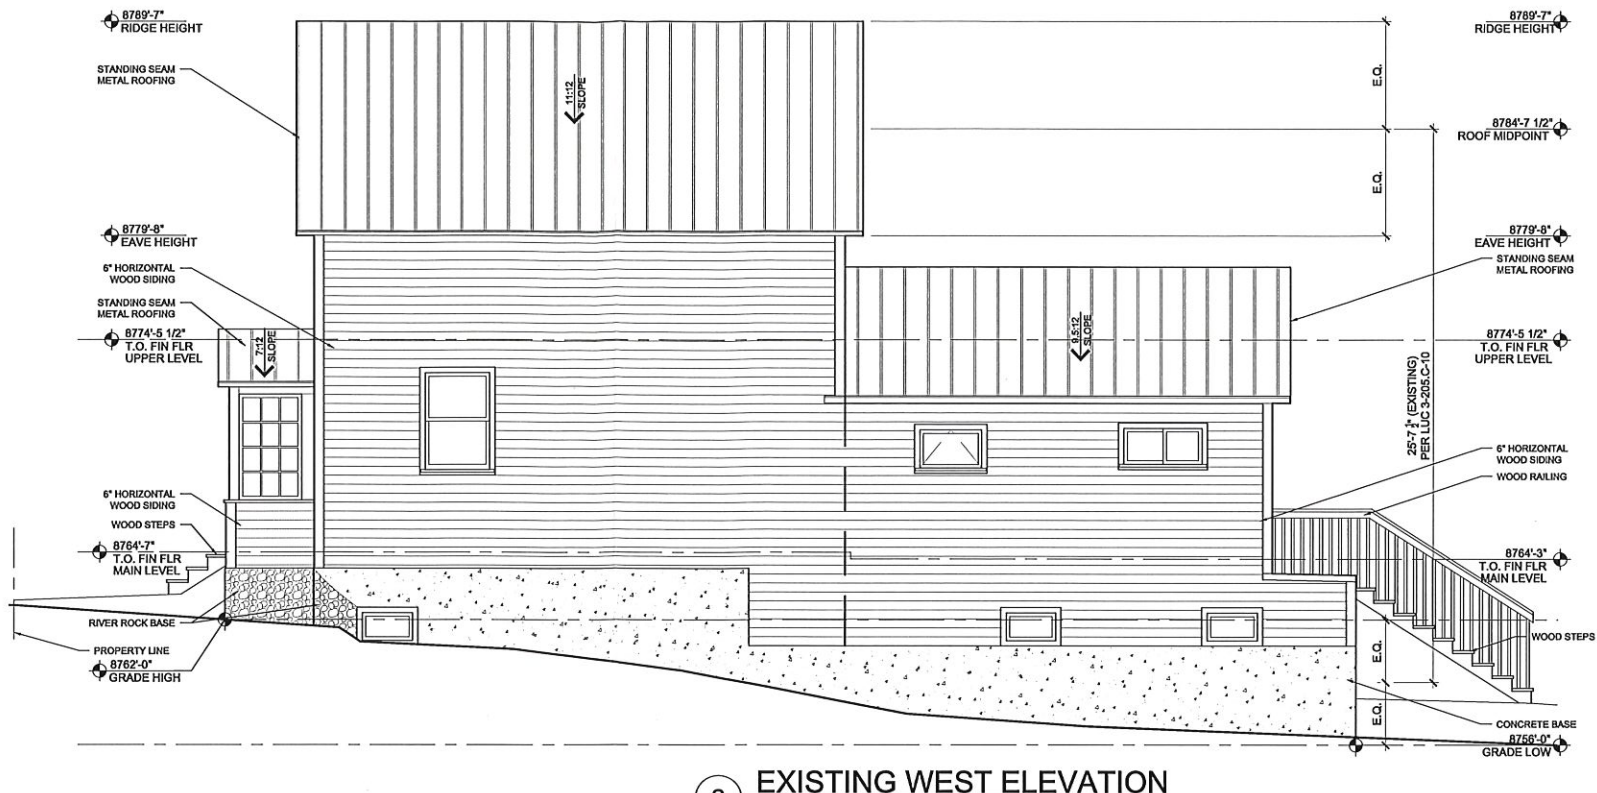
## A3.1

1. Change siding on historic house from 6" to 4" reveal
2. Add vent on east elevation
3. Add fireplace vent on south elevation
4. Add boiler flue termination on south side of chimney

| <b>Rehabilitation Standards (RE)</b> | <b>Staff Analysis</b> |
|---|--|
| <b>30. Utilities</b><br>A. Minimize the visual impacts of utilities and service equipment. | The vents and flue terminations are located on side and rear elevations. |
